Navajo Abandoned Uranium Mine

Site Screen Report

Cove Mesa Mines (Cato Sells) AUM Site

March 2010

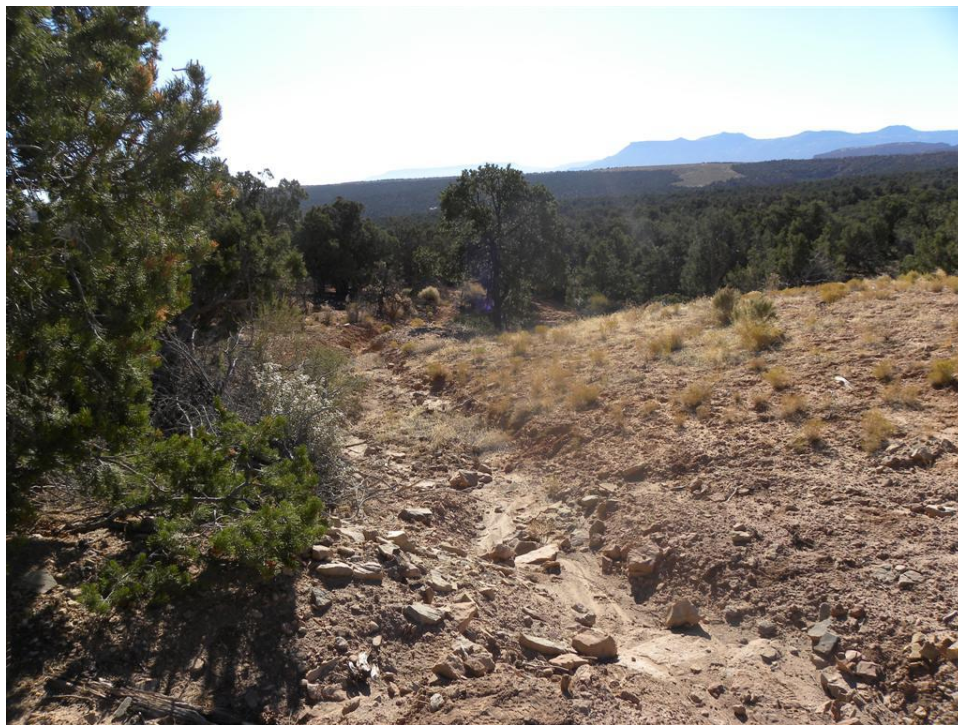
Clay/waste pile on east side of site, approximately 100' x 75' x 10' height, with a total estimated volume of 2,778 yd³

Photo 1. Site #34 – Mixed waste/clay pile

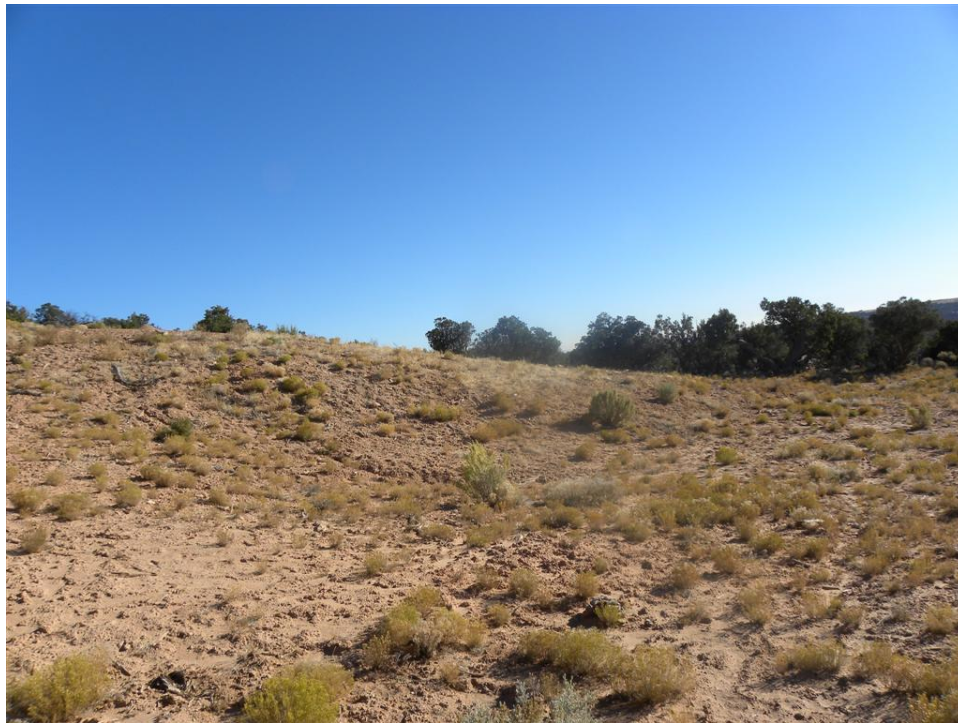
Photo 2. Site #34 – Mine site

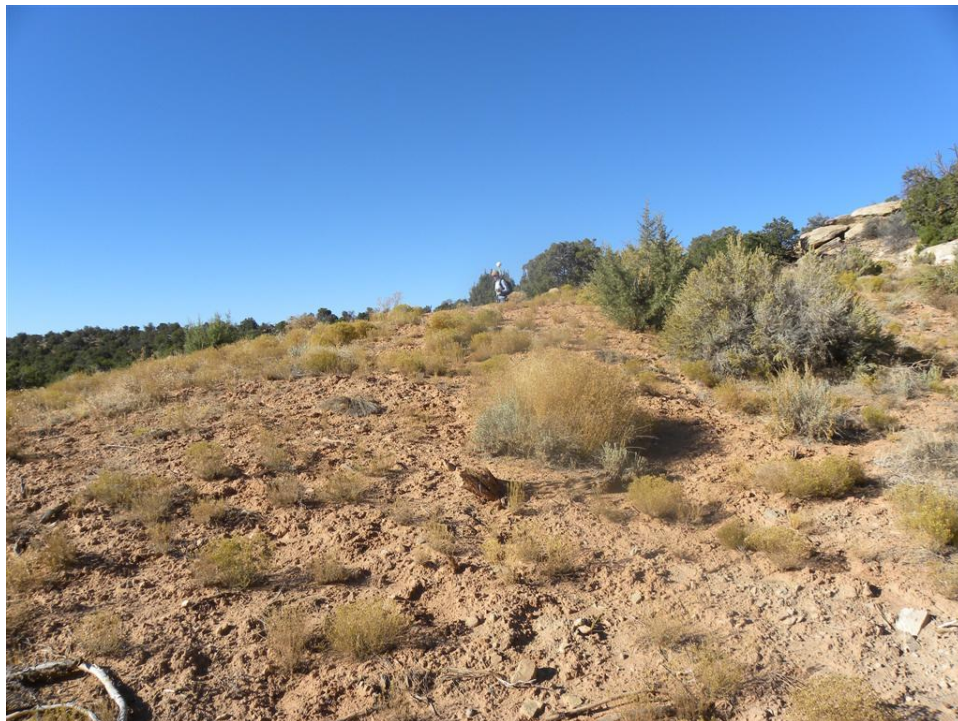
Photo 3. Site #34 – Mine site

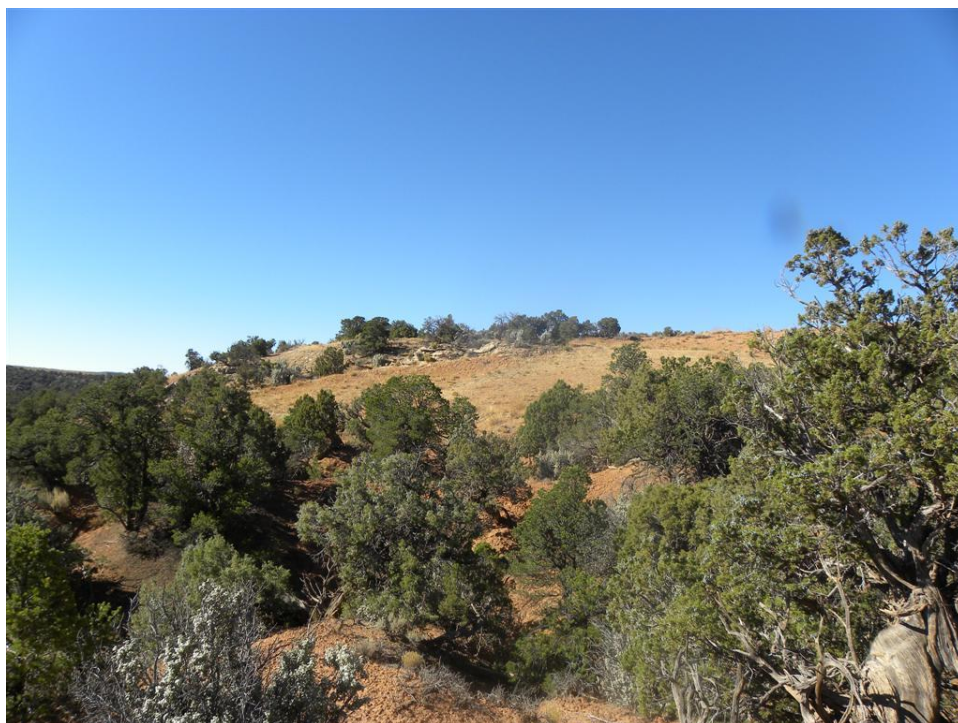
Photo 4. Site #35 – Mine site

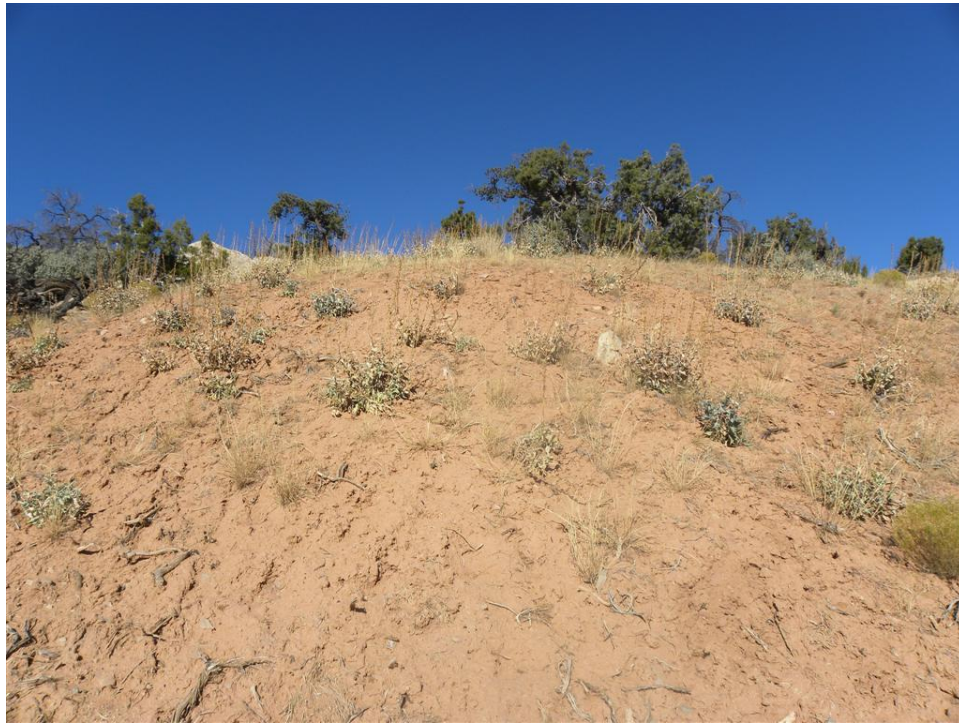
Clay/waste pile, approximately 50' x 50', with a total estimated volume of 925 yd³

Photo 5. Site #35 – Clay pile

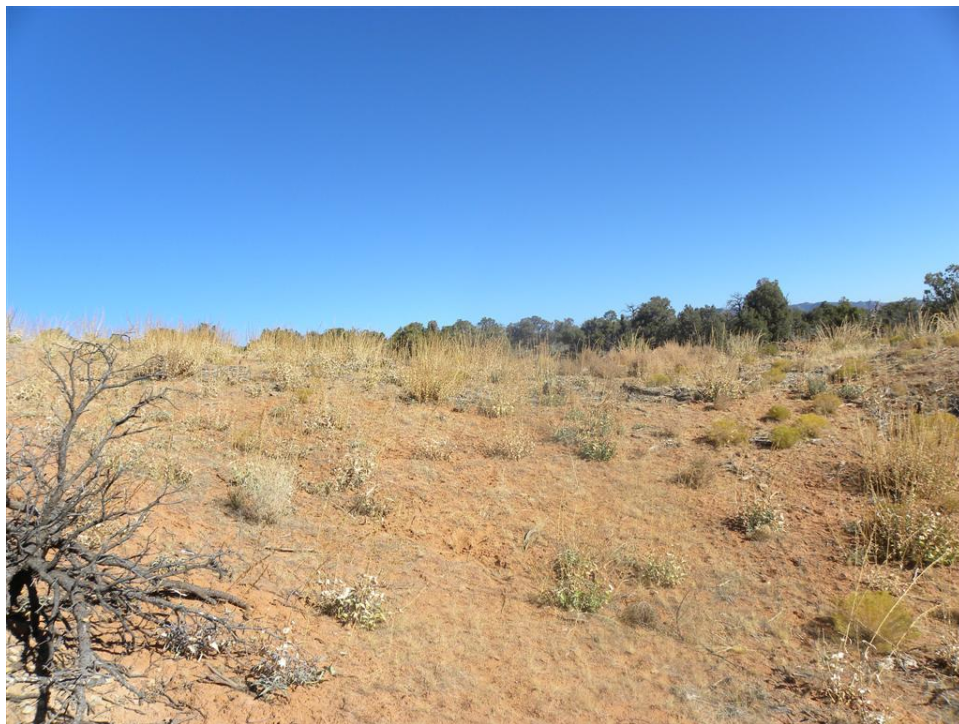
Photo 6. Site #35 – Mine site

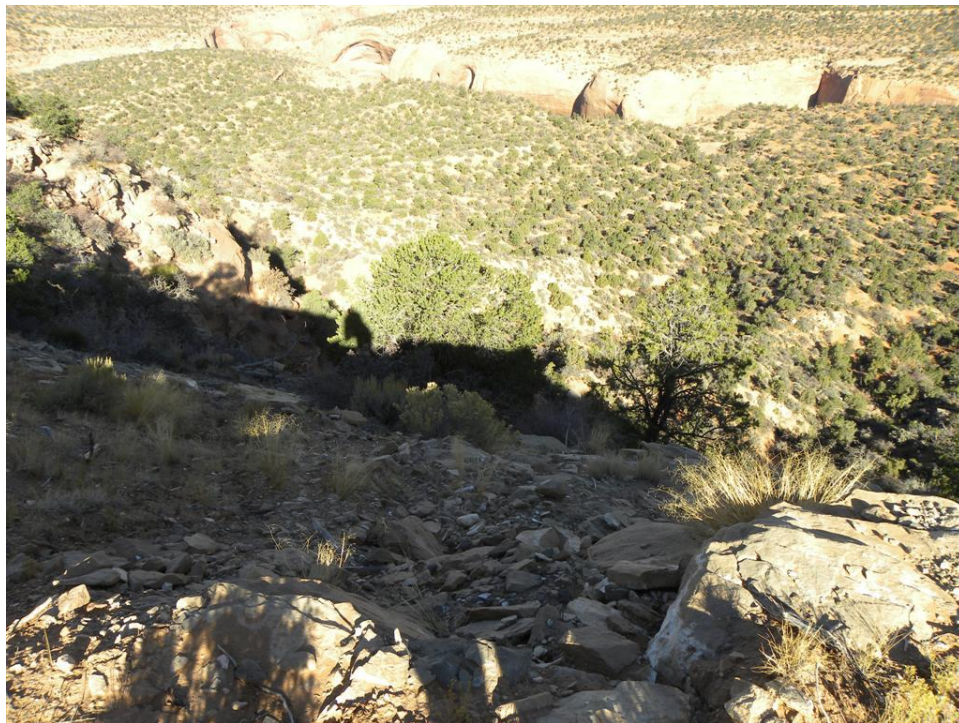
2 waste piles on east edge of site: approximately 50'x50'; 125' x 50'; with a total estimated volume of 1,620 yd³

Photo 7. Site #36 – Waste pile and cliff area

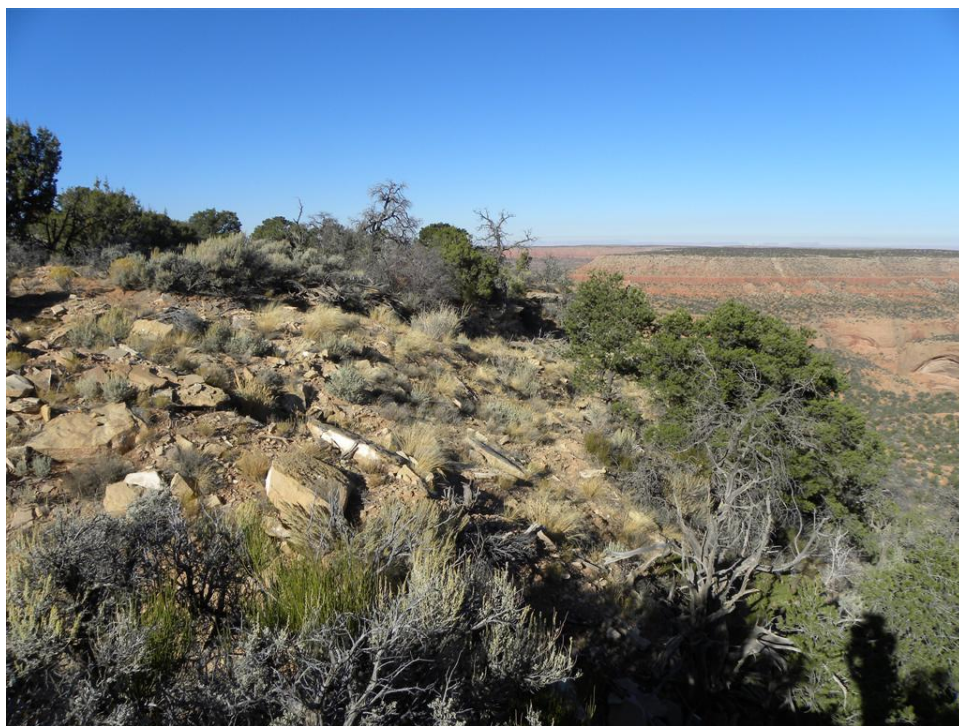
Photo 8. Site #36 – Mine site

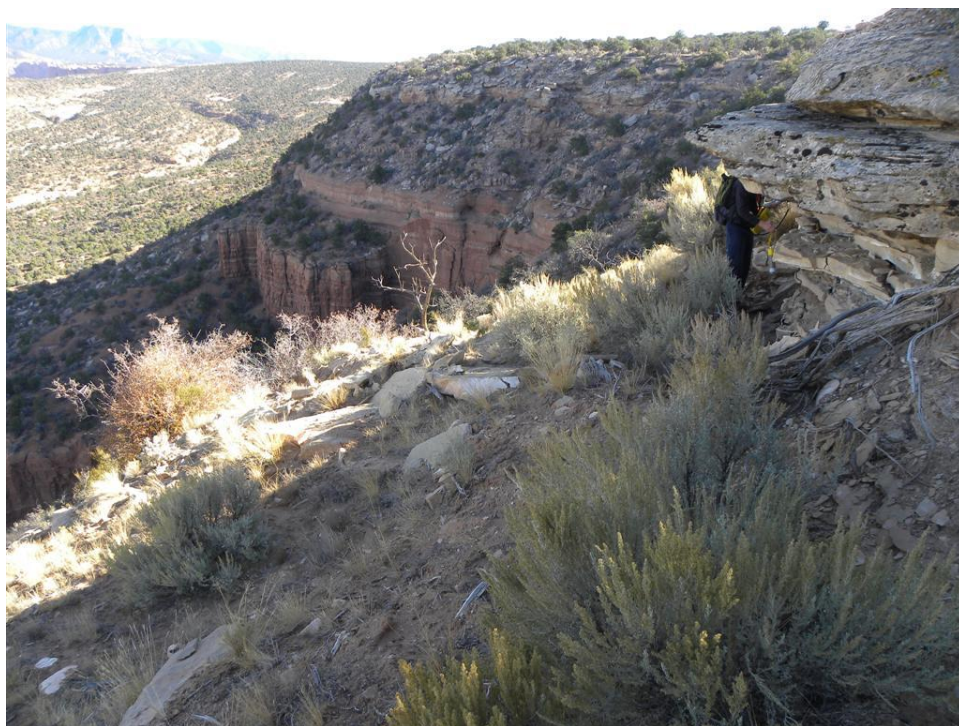
Photo 9. Site #36 – Waste pile and cliff area
